Rudge Remedies

No 9 – Main Bearing inspection & replacement – 500cc/350cc 1930 to 1939

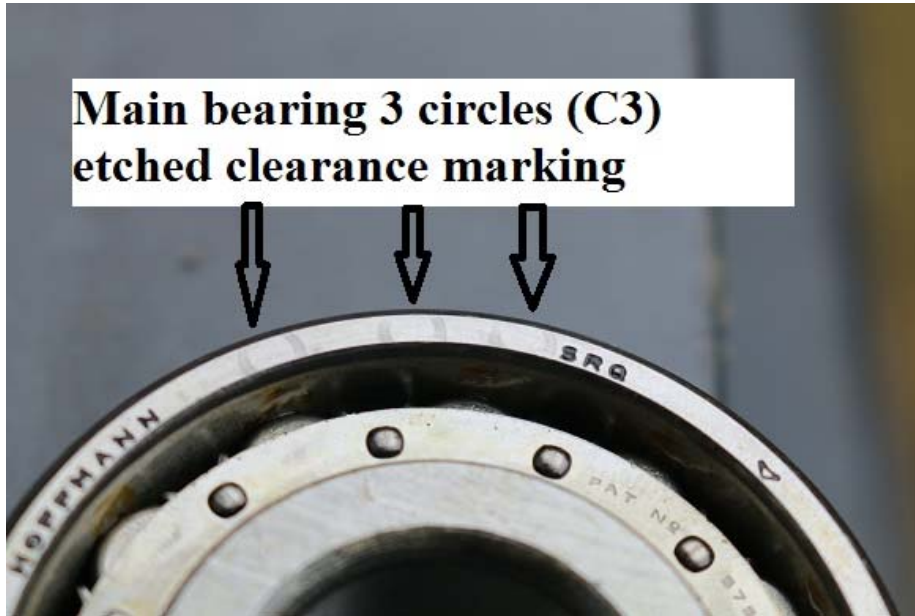
It is clear to see that as engine power developed, the specification of the main bearings changed along with a change in manufacturer. The different MRJ 7/8 prefixes indicate bearings with differing load characteristics. All original bearings had riveted bronze cages supporting the rollers and post 1930 were of C3 fit (RMS9/3 indicates a C3 fit and all MRJ 7/8 bearings had this clearance also). The introduction of C3 fit bearings was a necessity following problems with loose bearing outer rings in 1930 cured for 1931, by reducing the crankcase bearing aperture size for the main bearings from 2.2495" in 1930 to 2.247"/2.248". This reduction increased the clamping force on the outer race with a proportionate loss of internal radial clearance compensated for by using a C3 fit bearing. Bearings are categorised by their internal radial clearance with popular bearings ranging from '0' or C1, to '00000' or C5 fit with C5 having the greatest internal radial clearance. C3 fit bearings ('000') are generally specified for all air cooled engines with aluminium bearing housings where both races are an interference fit because, when fitted, the outer race tends to be squeezed smaller by the contracting aluminium housing and the inner race stretched over the shaft, thus reducing the internal bearing clearance. The fit is generally marked on bearings by either a number of circles etched or scuffed into the outer ring or the 'C' fit etched or stamped into either inner or outer ring face often as a 'V3'. Unless

specified, bearings are now supplied with a 'CN' radial clearance between C2 and C3 and are unmarked.

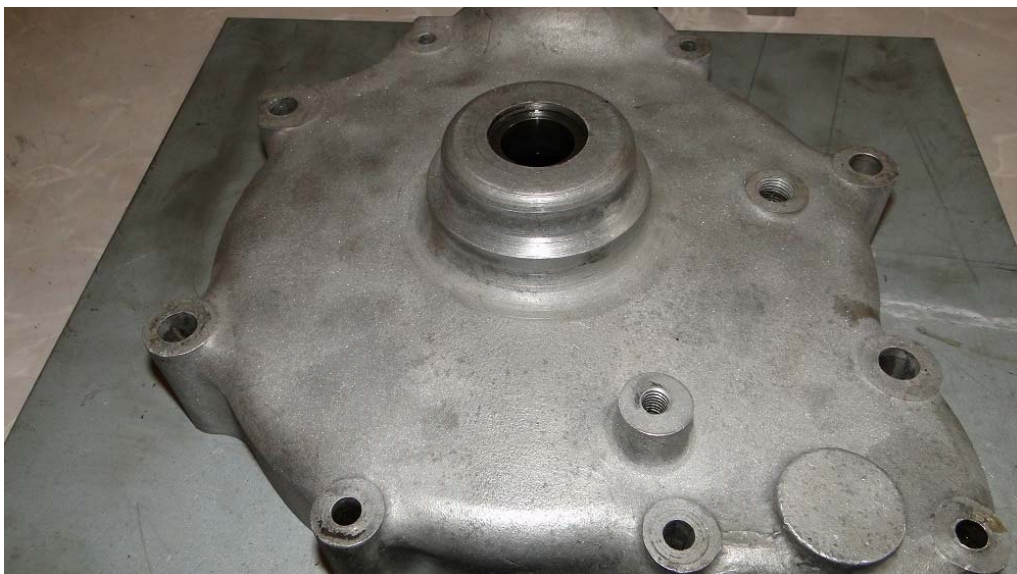
Note that it appears that some later 1939 crankcases were not drilled for a lock ring grub screw! (see above). In this case, the drilling can be added 0.8"/0.88" from the outside bearing face or, as an alternative, threadlock can be used to secure the lock ring once the ball bearing has been installed and the crankcase cooled.

The grub screw must now be replaced (1/4” x 20TPI Whitworth thread). Often, the hole drilled in the lock ring will **fully** align with the grub screw hole and the grub screw can just be replaced using a spot of thread locking compound. If the lock ring drilling has not **fully** aligned, **do not unscrew the lock ring in an attempt to realign the grub screw as this could subsequently allow the bearing to rotate in its housing resulting in damage to the crankcase.** If no part of the original lock ring hole is visible, the lock ring will need to be redrilled. To re-drill the lock ring to accept the grub screw, it is best to use a pilot to avoid damage to the grub screw thread. (A 1/4” Whit bolt drilled down the centre to accept a 5/32” drill is ideal for this). Using a pilot, re-drill the lock ring, clean out any swarf, and fit the pointed grub screw using a spot of thread locking compound. Make sure that the grub screw is not proud of the crankcase surface or it could interfere with the chaincase sealing felt arrangement. If the original lock ring drilling is **partially** visible then redrilling is best avoided due to the probability of the drill wandering into the original hole. Under these circumstances, remove the lock ring reduce its width by approximately 0.005” to 0.010” to reposition the original lock ring hole so that a new lock ring hole can be drilled. An alternative, is to substitute the lock ring with another.

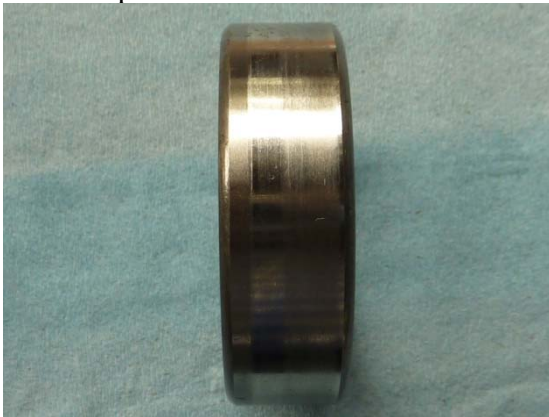
- a) Loose main bearing outer races – Outer races should be a tight fit in the crankcases and it should not be possible to remove them at room temperature. A bearing that has been spinning in use can be spotted by a polished outer as in the picture below. This outer ring is from a timing side bearing where the portion which protrudes from the case can be clearly seen.

Slight looseness can be corrected using Loctite bearing fit but remember that Loctite is destroyed by excessive heat and the bearing race should therefore be replaced after all other work has been completed on the crankcase half. More severe looseness can be corrected by plating the outer surface of the outer race with either copper or nickel. Before plating, the bearing ring should be shielded using 2 disc washers spaced by an internal spacer and held together by a nut & bolt to leave only the outer surface of the race visible. The inner race area should be greased and the discs bedded on instant gasket to prevent penetration of the plating fluid. The central bolt should also be sealed using instant gasket. (see Fig 1 below). Before delivering to the platers, a check must be made to ensure that the central bolt is in electrical contact with the race to ensure plating takes place. A multimeter or battery & bulb can be used for this. The original dimension of the bearing housing was 2.247" to 2.248", with a nominal bearing OD of 2.250" giving a 0.002" to 0.003" interference fit. (note that as explained earlier, 1930 crankcases had a slightly larger bearing aperture of 2.2495" but ideally, the later 0.002" to 0.003" interference fit should be the aim.)

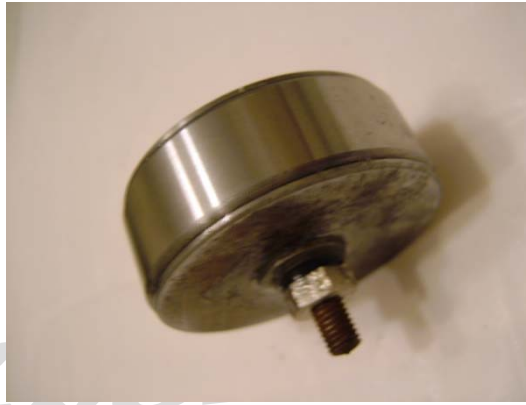
Fig 1: A bearing outer race prepared for plating
